HAMBLETON DISTRICT COUNCIL

Report To: Planning Committee
24 May 2012

Subject: **HAMBLETON DISTRICT COUNCIL (AISKEW) TREE PRESERVATION ORDER
2012 No. 3**

Re: ASSESSMENT OF OAK TREE AT AISKEW, BEDALE

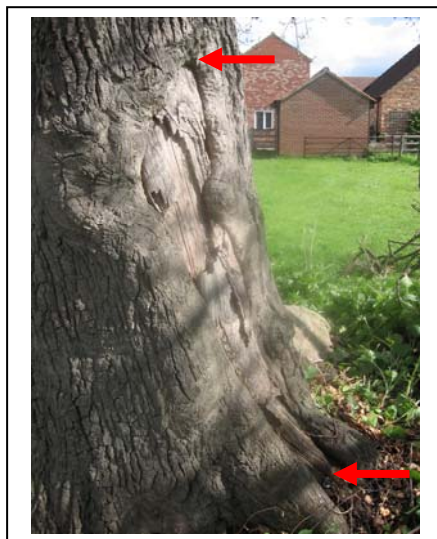
A number of dead branches were stacked against the southern face of the tree and the barbwire boundary fence. The loose branches were removed to give access, exposing a longitudinal wound on the south western face of the main stem which extends from ground level to roughly 1.3 metres above ground level as indicated by the red arrow on the photograph opposite.

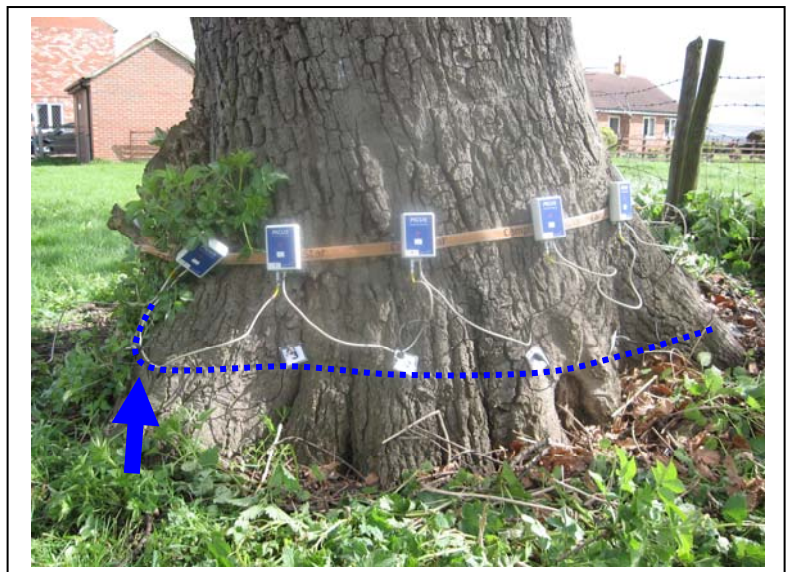
The sonic assessment was undertaken at 250mm above ground, indicated by the blue dotted line on the photograph below; the blue arrow shows the position of Sensor 2.

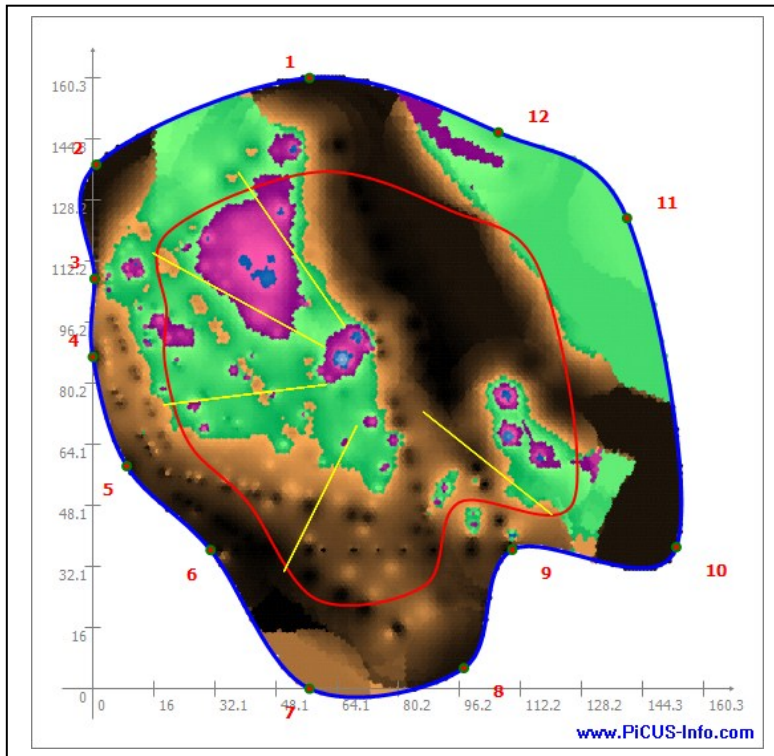
The results of the Sonic Tomography are shown opposite. This Tomograph indicates that the stem has undergone significant alteration indicated by magenta areas, showing the areas where sound propagation has been restricted.

The green area indicates that the surrounding wood is undergoing early stage fungal colonisation with early stage limitation of the sound signal.

The brown areas represent the better quality sections of wood which are unlikely to be affected by fungal activity at the current time.

In addition to the decayed sections the tree is affected by a series of radial cracks that are indicated by the yellow lines on the image above, these are a relatively common feature on this species in this region and not expected to relate to the trees stability.

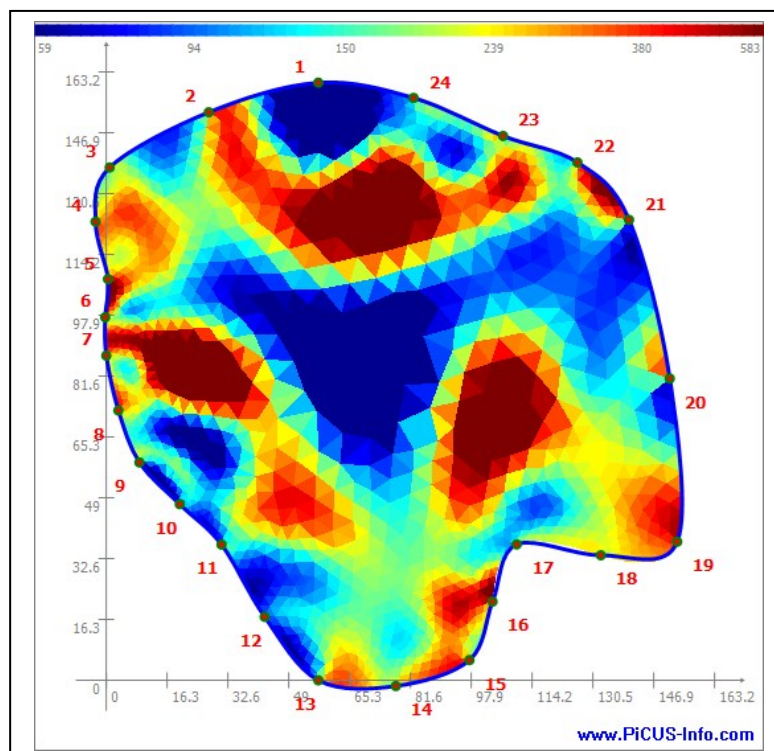
The extent of significantly decayed wood is close to and in some areas the inner red line, which represents the typically accepted safe limit of hollowing within a stem.

The results show the tree to have areas of high resistance in the areas indicated red. In the outer stem areas of low moisture are present as the sap flow is restricted in relation to localised root damage or early stage vascular dysfunction.

The central stem shows signs of localised drying out of the wood as the fungi begins alter the internal humidity of the wood to meet its own requirements, this is assumed to be the area of greatest fungal activity.

This tomography aligns reasonably well with the sonic results showing the stem and its internal defences which have been breached, and are altering the normal moisture distribution pattern.

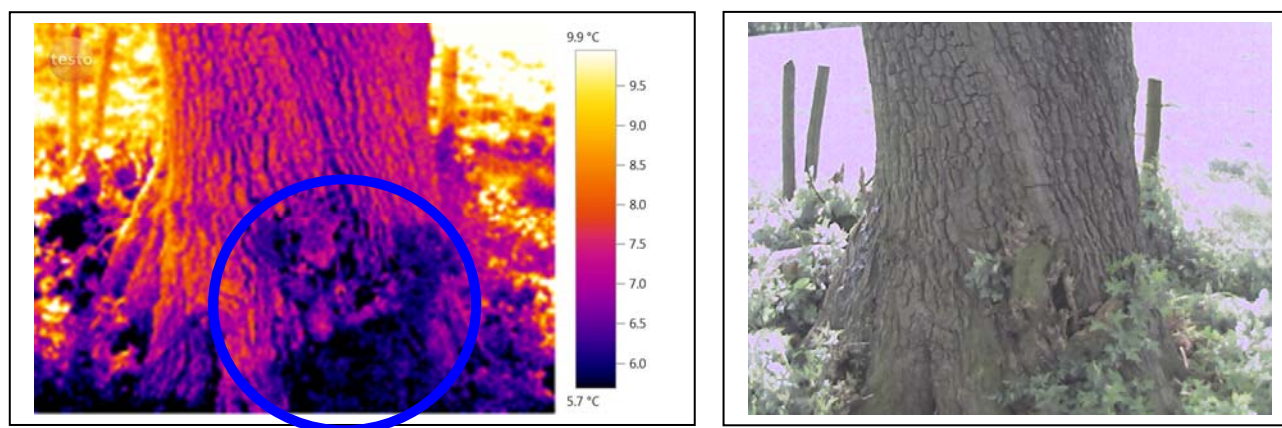
The above thermogram shows that the northern face of the stem has a distinct cooler area in the central lower section within the blue ring. This shows an area of dysfunction in the vessels which has restricted sap flow limiting the heat distribution between the SOT sensor points 1 & 2.
