HAMBLETON DISTRICT COUNCIL

Report To: Planning Committee
24 May 2012

Subject: **HAMBLETON DISTRICT COUNCIL (AISKEW) TREE PRESERVATION ORDER
2012 No. 3**

Re: ASSESSMENT OF OAK TREE AT AISKEW, BEDALE

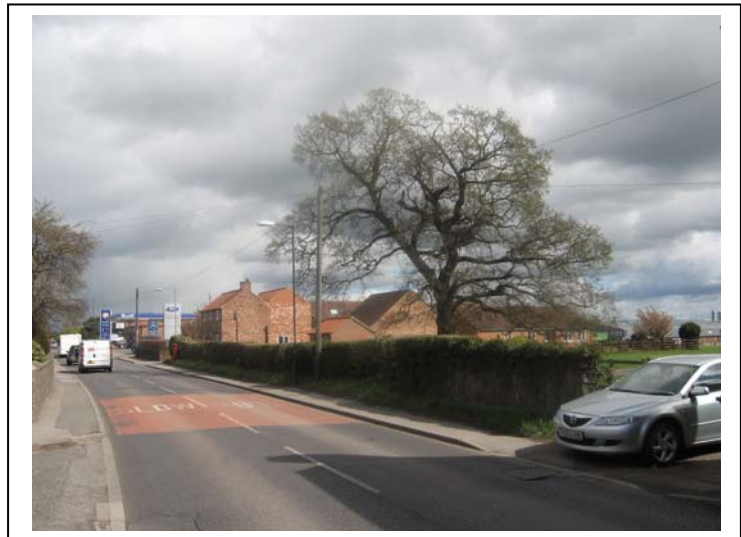
Please find my assessment of the mature Oak located close to the southern boundary of the triangular paddock located to the west of Morpeth House and adjacent to the busy A684 as shown in the photograph opposite.

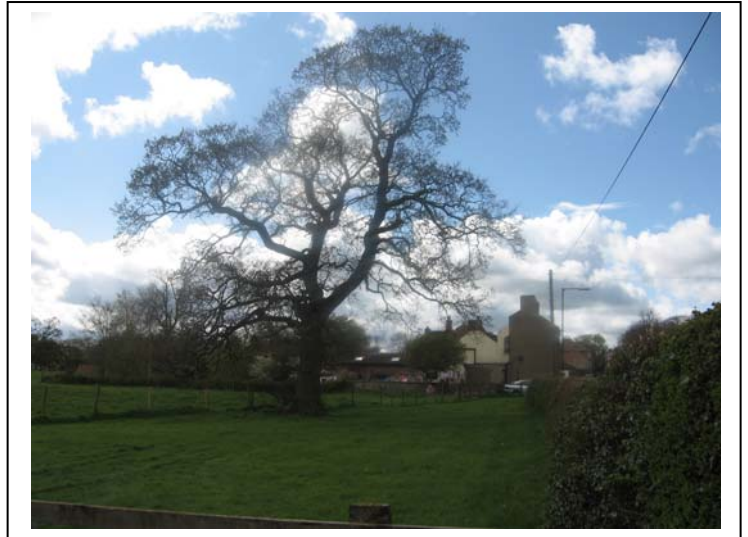
Comments: The tree is located within a regularly maintained grass paddock with grassed pasture to the south.

A number of dead branches were stacked against the southern face of the tree and the barbwire boundary fence. The loose branches were removed to give access, exposing a longitudinal wound on the south western face of the main stem which extends from ground level to roughly 1.3 metres above ground level as indicated by the red arrow on the photograph opposite.
