FINAL OPTIONS PAPER NORTHALLERTON CONNECTIONS

5. ZETLAND STREET PROPOSALS

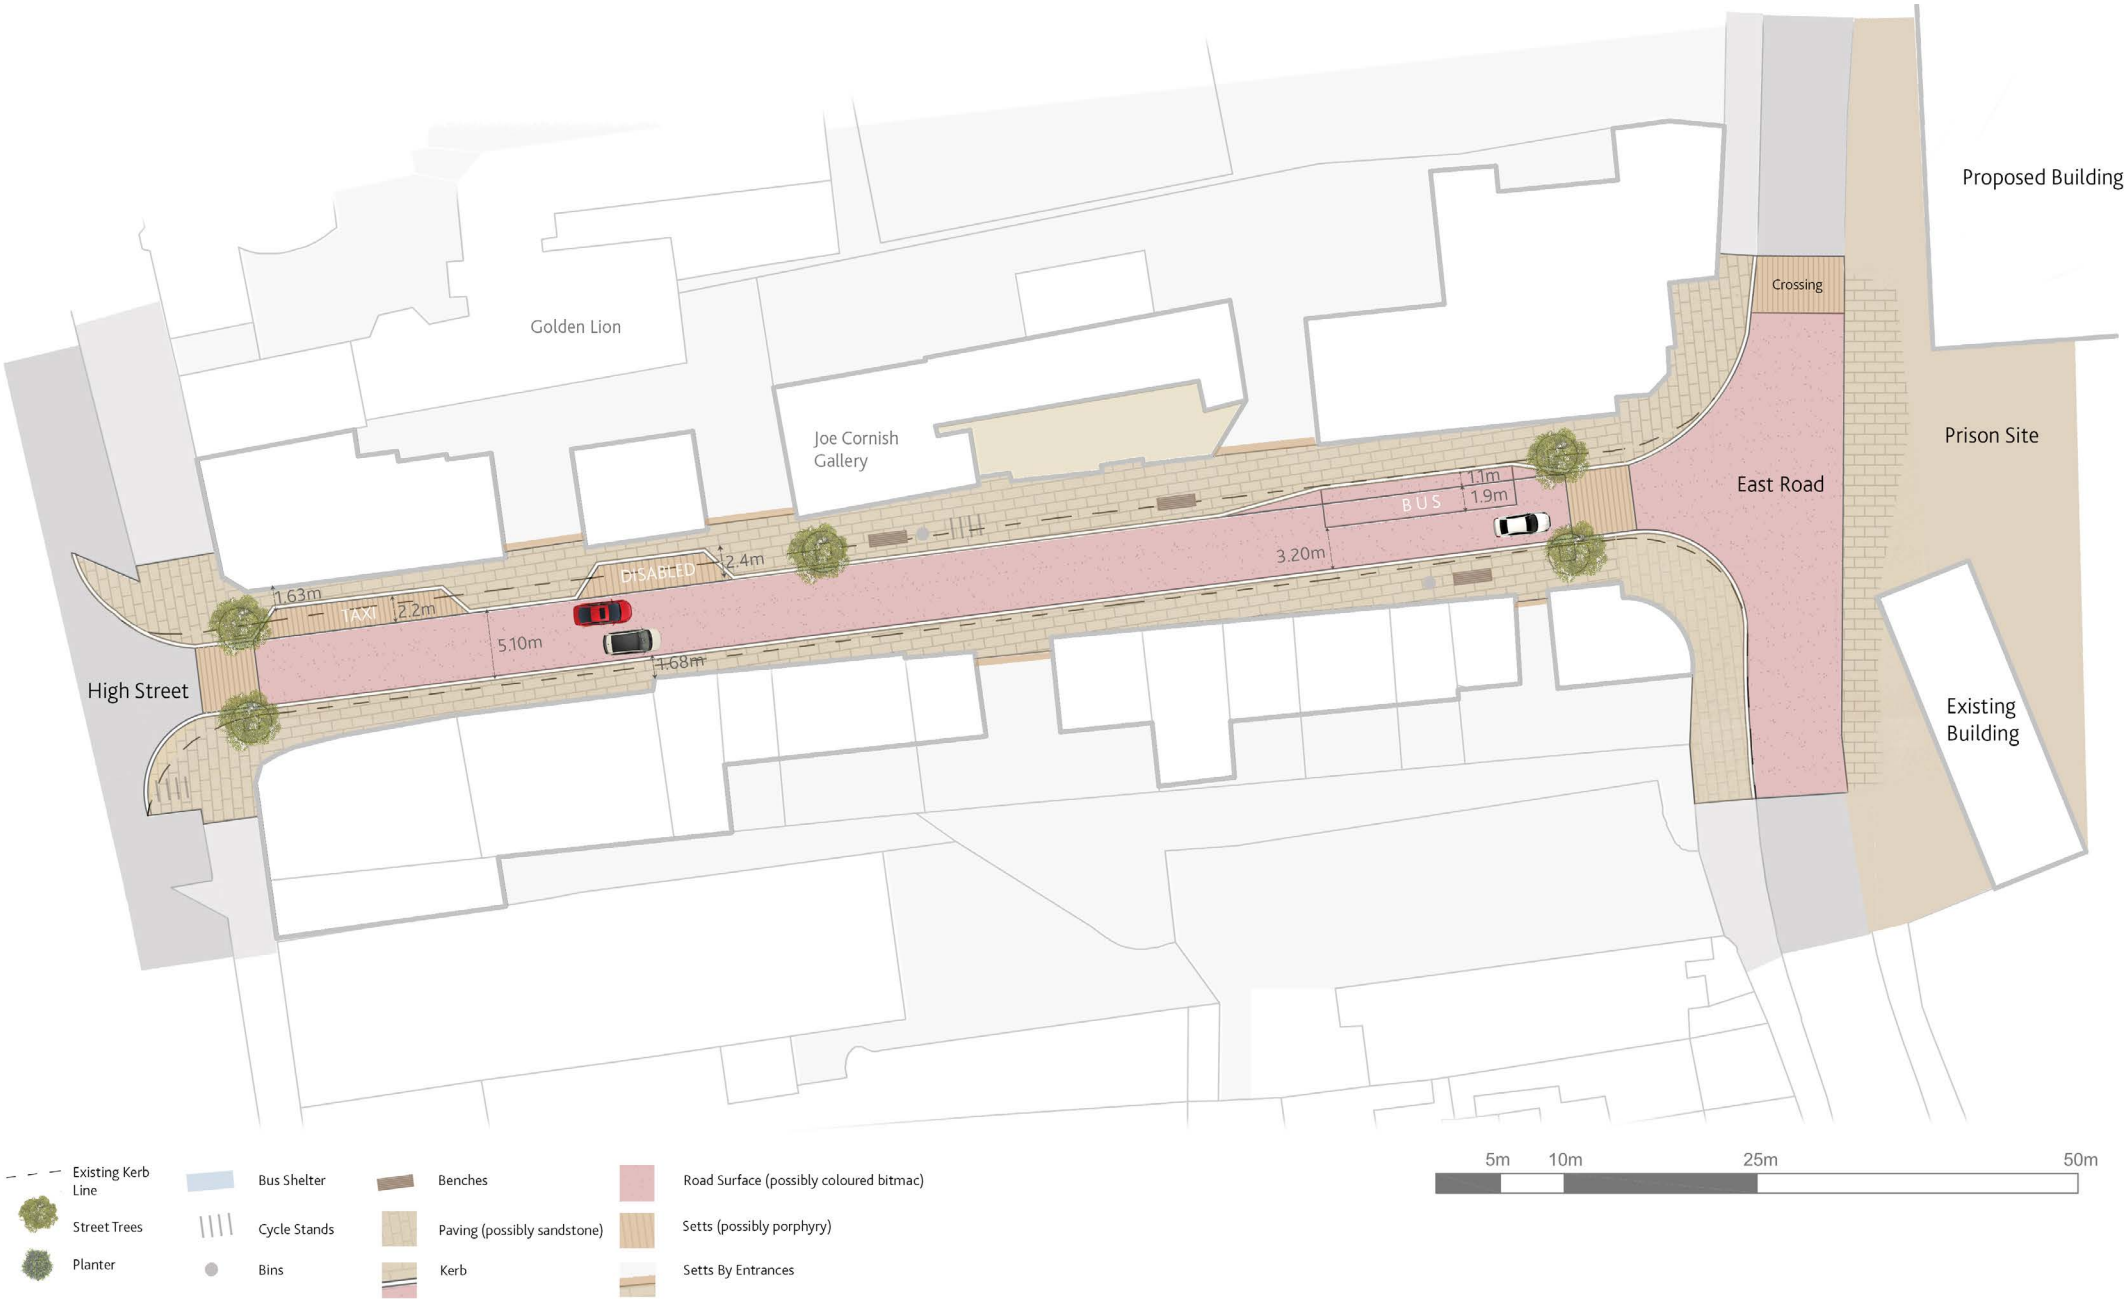
Option 1

A clean symmetrical design with increased footpath widths and tree planting.

Key features:

- Improved pavement widths (by approx. 1m either side)
- Carriageway narrowed to two lane 5m road – single track at bus stop
- Clean symmetrical design incorporating paved taxi bays, disabled parking and bus stop
- Setted entrances to back yards off Zetland Street
- Semi-mature tree planting softens the street and gives it an appealing character
- Potential development sites either side of Zetland Street – East Road junction

Challenges:

- Traffic volumes and loss of service/short stay parking
- ***Bus standards taken from London guidance***
- ***Paving widths too narrow on both sides of the road ; pinch points measuring 1.63 and 1.68m***
- ***Loss of 4 parking bays***

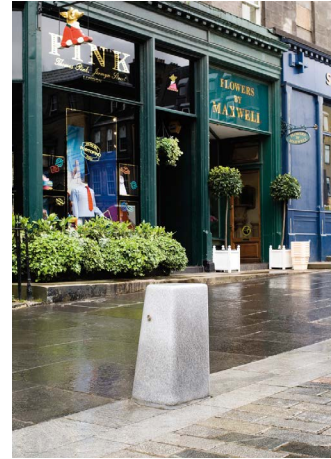
High quality materials,
Castle Street, Edinburgh

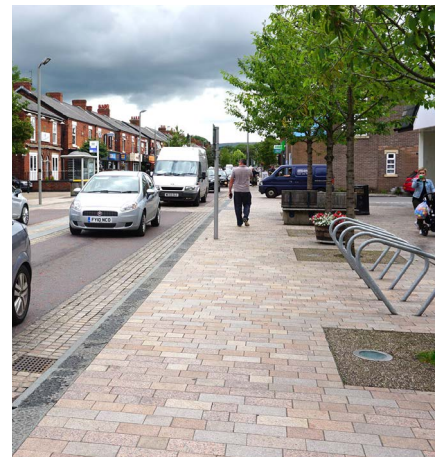
Narrowed carriageway, Poynton

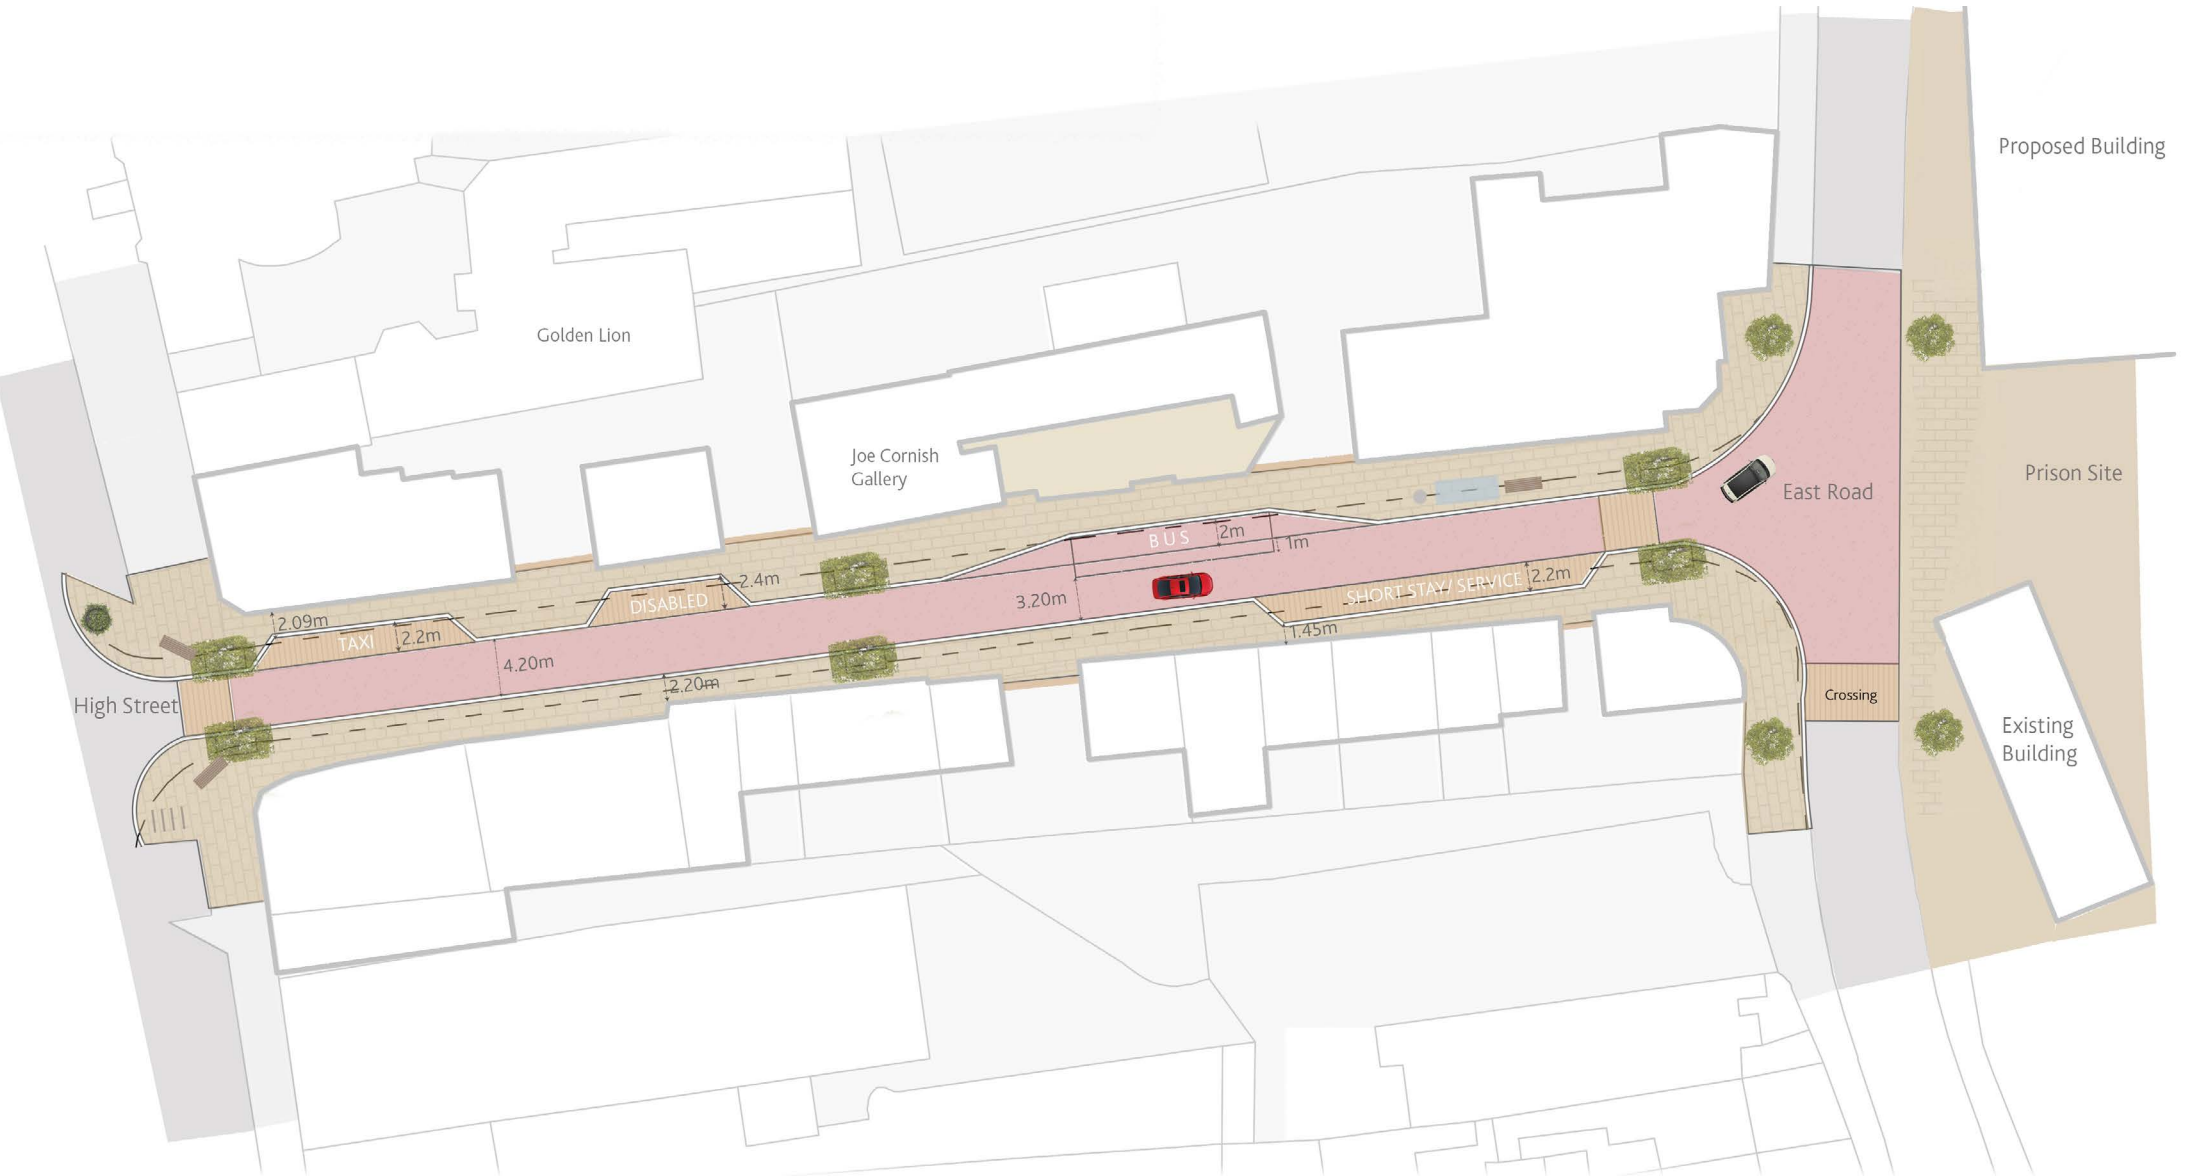
Option 3

A clean design significantly narrowing the carriageway to one lane

Key features:

- Improved pavement widths (between 1 and 2 metres) particularly at J. Cornish Gallery and the shops opposite
- Carriageway narrowed to one 3.5m lane widening to two lanes at East Road
- Paved taxi bays, service parking/service bays and bus stop incorporated
- Pleached tree planting formalises the visual axis along Zetland Street
- Potential development sites either side of Zetland Street – East Road junction

Challenges:

- Traffic volumes on single lane road formal tree arrangement and utilities
- *Bus standards taken from London guidance*
- *Paving widths too narrow on southern side of road; pinch point measuring 1.46m, however parking bay could be removed*
- *Loss of 1 parking bay*

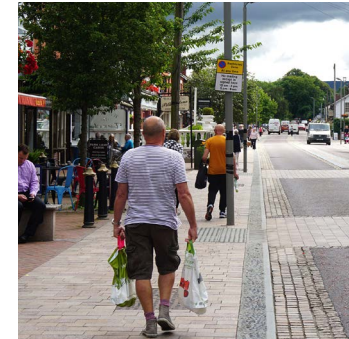
Options for materials;
asphalt and natural stone
